DEPARTMENT OF THE ARMY PERMIT

Permit No: SAJ-2017-00416 (SP-JCM)

The project consists in the installation of a Single Point Mooring (SPM) and an underwater pipeline system for the offshore transfer of liquid petroleum products from Very Large Bulk Carriers (VLBCs) to the existing facilities at the Limetree Bay Terminal. This project will provide Limetree Bay Terminals, LLC the ability to receive shipments from VLBCs with drafts up to -76 ft below mean sea level (MSL) without docking at the land-based operations or having to transfer fuel to smaller vessels. The VLBCs would moor to the SPM in deep water (>600 ft), connect to suspended hose lines that will be attached to the pipelines, and off load their products through the transfer system.

PURPOSE:	INSTALLATION OF A SINGLE POINT MOORING SYSTEM FOR BULK FUEL SHIPMENTS	OWNER:	LIMETREE BAY TERMINALS, LLC	 LLOYD ENGINEERING, INC. HOUSTON, TEXAS, USA LICENSE NO. 32262	DESIGN BY:	GAB
		APPLIED BY:	LLOYD ENGINEERING		DRAWN BY:	RC
		APPLIC. No:	XXX		SCALE:	AS NOTED
		COUNTY:	XXX		DATE:	05/02/18
		WATER BODY:	CARIBBEAN SEA		SHEET No:	
LOCATION:	U.S. VIRGIN ISLANDS UNITED STATES	DATUM:	NAD83			2

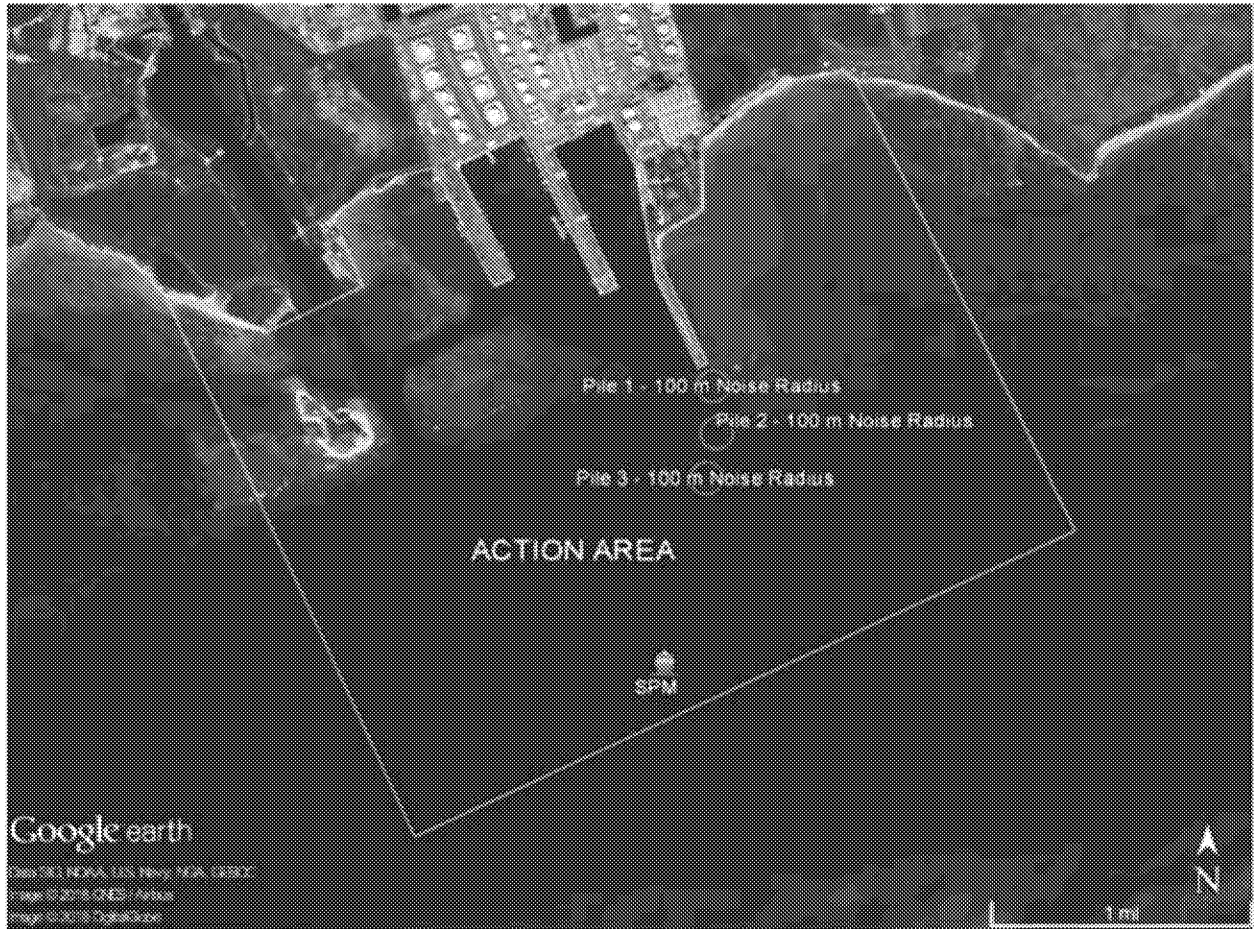
Figure 14. Action Area with Noise Effect Radii Analysis

For the purposes of this consultation, the USACE has defined the Action Area to include approximately 3,750 ac of navigable waters, which could be subject to the potential direct and indirect impact of the proposed project. The boundaries of this Action Area are depicted in Figure 13 below. This area includes: the shoreline and navigation channel of the Limetree Bay Terminal Facility; the footprint and all work areas of the proposed project; and the adjacent navigable waters extending 1.0 mi to the northeast and 1.5 mi to the southwest of the proposed trenching work and pipeline footprint, as well as 0.25 mi to the southwest of the proposed SPM

anchors, etc.) during the proposed construction work. Green, loggerhead and hawksbill sea turtles were observed in the Action Area during benthic surveys conducted for the project. The Action Area (Figure 14) is located along the southern shore of St. Croix, so access to open water is not impeded in any way for sea turtles that may be in the area during operation of in-water construction machinery. The trenching and pile-driving barge will be anchor or spud in place while conducting in-water work. The pipeline laying barge will not set anchor or spuds, but would be moving at very low speeds. As a result, sea turtles will be able to hear and see in water construction machinery. We expect any animals that approach the in-water work areas to swim away. The applicant will operate in compliance with NMFS *Sea Turtle and Smalltooth Sawfish Construction Conditions*, dated March 23, 2006. The implementation of the construction conditions will provide protection to sea turtles by requiring temporary work stoppages to protect any sea turtles that approach the in-water work area. Limetree Bay Terminal's contractor will also implement a sea turtle and marine mammal monitoring program during the proposed work, which will include training of personnel involved in in-water work as observers. Therefore, the NMFS believes the risk of injury from in-water construction machinery will be discountable.

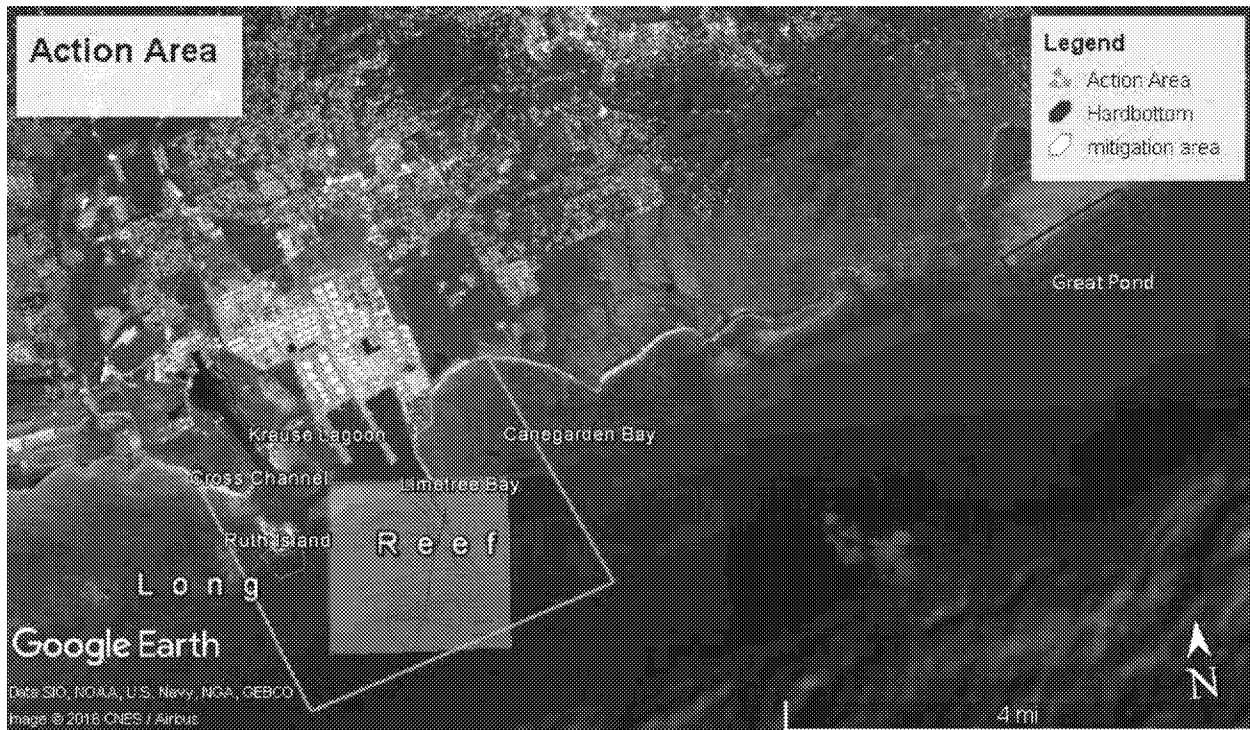
Figure 15. Action area with Key Areas

location. The Action Area encompasses the extent of Long Reef, particularly the waters around Ruth Island, which is located approximately 1.25 mi to the northwest of the proposed trenching work and pipeline footprint. In addition, the Action Area encompasses the western portion of Cane Bay (Figure 15). The action area includes the coral mitigation site at Great Pond as shown in Figure 11, and the VLBC pilot boarding area (Figure 16) 2-3 miles offshore the Limetree facility. The action area also includes all areas corals of opportunity are collected from (the coasts of St. Croix and other USVI territories if necessary) and the TNC nurseries.

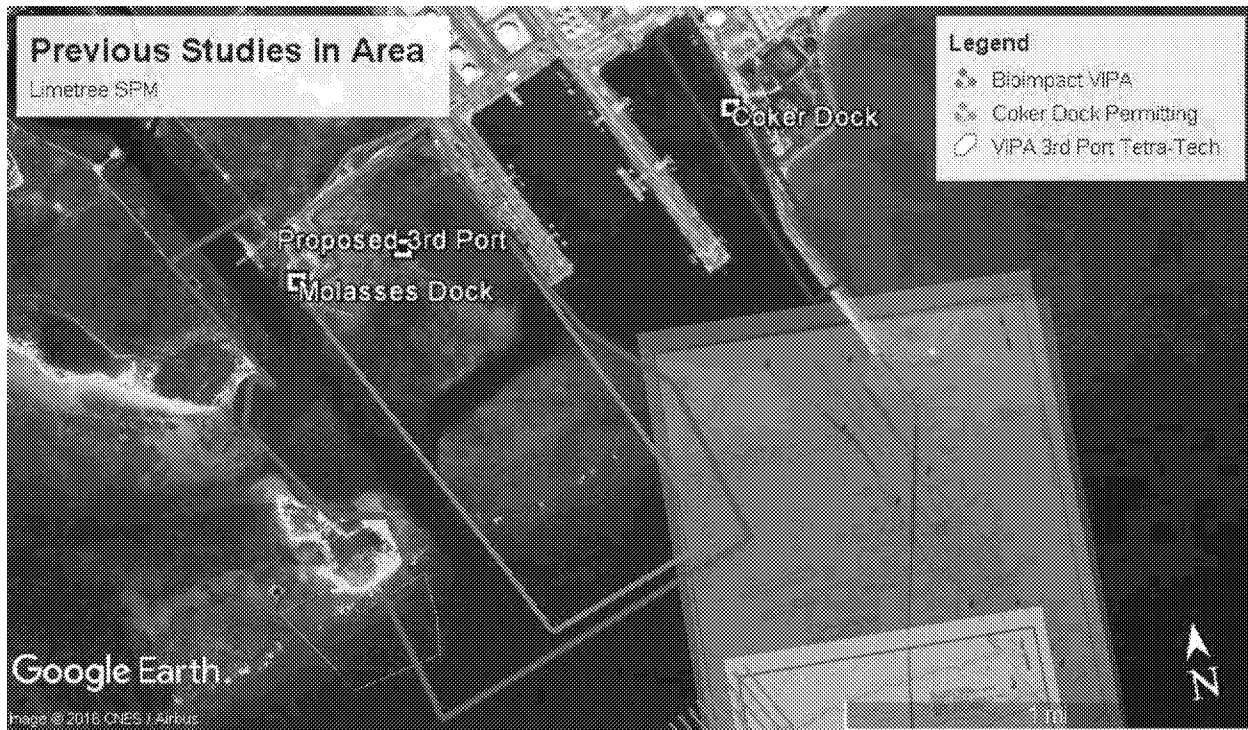
Figure 19. Previous Studies in the Action Area

According to the applicant, studies done by Tetra-Tech in 1973 in association with the Virgin Islands Port Authority's (VIPA)'s Third Port project reported the presence boulder star coral on the reefs to the west of the project site between the channels during surveys both deeper and shallower than 12m (Figure 19). Boulder star, lobed star and mountainous star corals have been reported by Bioimpact, Inc. during environmental studies for the Molasses Dock Expansion projects (Figure 19) and dredging projects on the reefs to the west (2013, 2017, 2009, 1993, 1986). Bioimpact, Inc., also reported lobed star corals on the revetment near the Coker Dock during the permitting of the dock, which allowed the refinery to make other refined products (2000) (Figure 19).

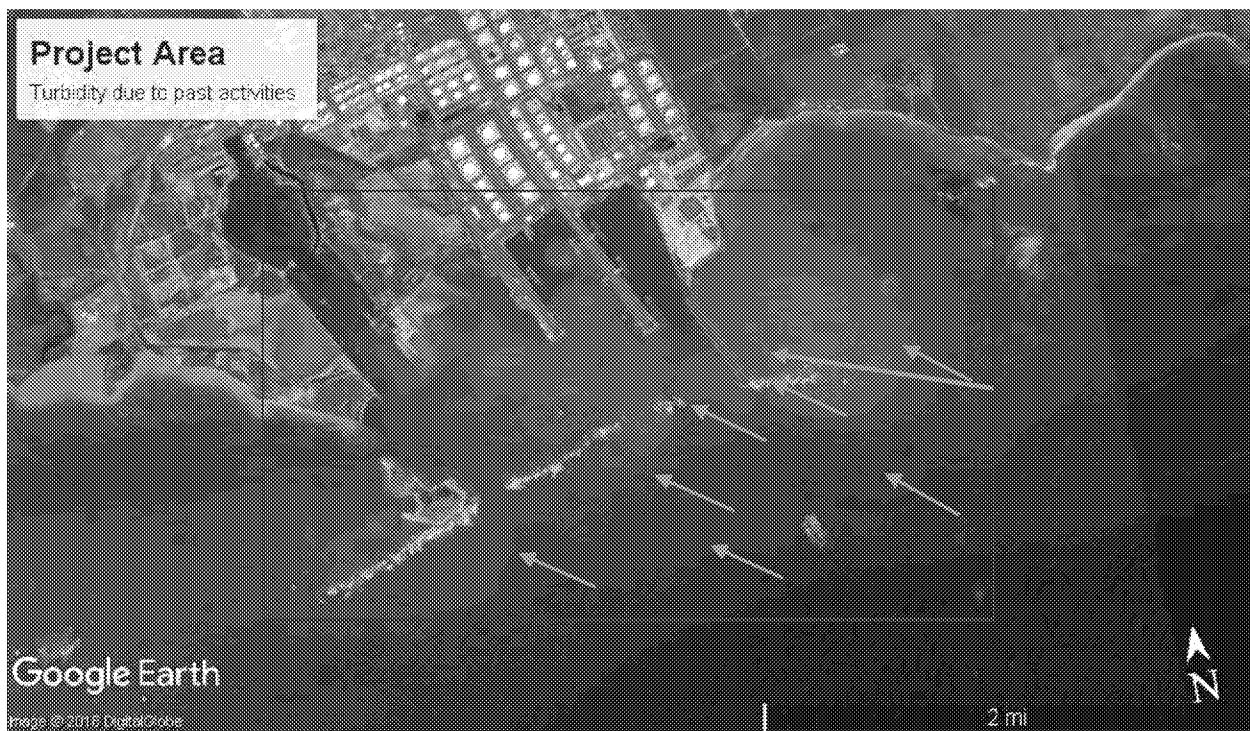
Figure 21. SPM landing site as shown by the orange arrow. The green arrows point out the layers of turbidity and sedimentation plumes created by the southern swell. The plumes in the western turning basin maybe the result of ship activities. Note that plumes are present to the west well along the shoreline.

The development of the south shore industrial complex began with the dredging of the Harvey Alumina Channel in the early 1960's and the filling of the Krause Lagoon wetlands. The initial dredging was done by blasting through the reef and the suction dredging and deposition of fill into the wetland. At the time due to limited environmental regulations, no turbidity control was implemented. Over the next 14 years, dredging and filling projects will be undertaken in the area with the creation of the refinery and marine terminal, which is now Limetree Bay Terminals. Within the area, there are large accumulations of very fine sediment, which originated from dredging and blasting. When seas are rough or large vessels transit the channels and the harbor, they suspend these sediments and the entire inshore area beyond the shelf drop becomes extremely turbid and remains so for extended periods. The aerial shows turbidity and sedimentation plumes observed in the area (Figure 21).

According to the applicant, the development of the south shore industrial complex (what is now Limetree Bay Terminals) began with the dredging of the Harvey Alumina Channel in the early 1960's and the filling of the Krause Lagoon wetlands. Within the area, there are large accumulations of very fine sediment, which originated from dredging and blasting. When seas are rough, they suspend these sediments and the entire inshore area beyond the shelf drop becomes extremely turbid and remains so for extended periods. The aerial shows turbidity and sedimentation plumes observed in the area (Figure 21).

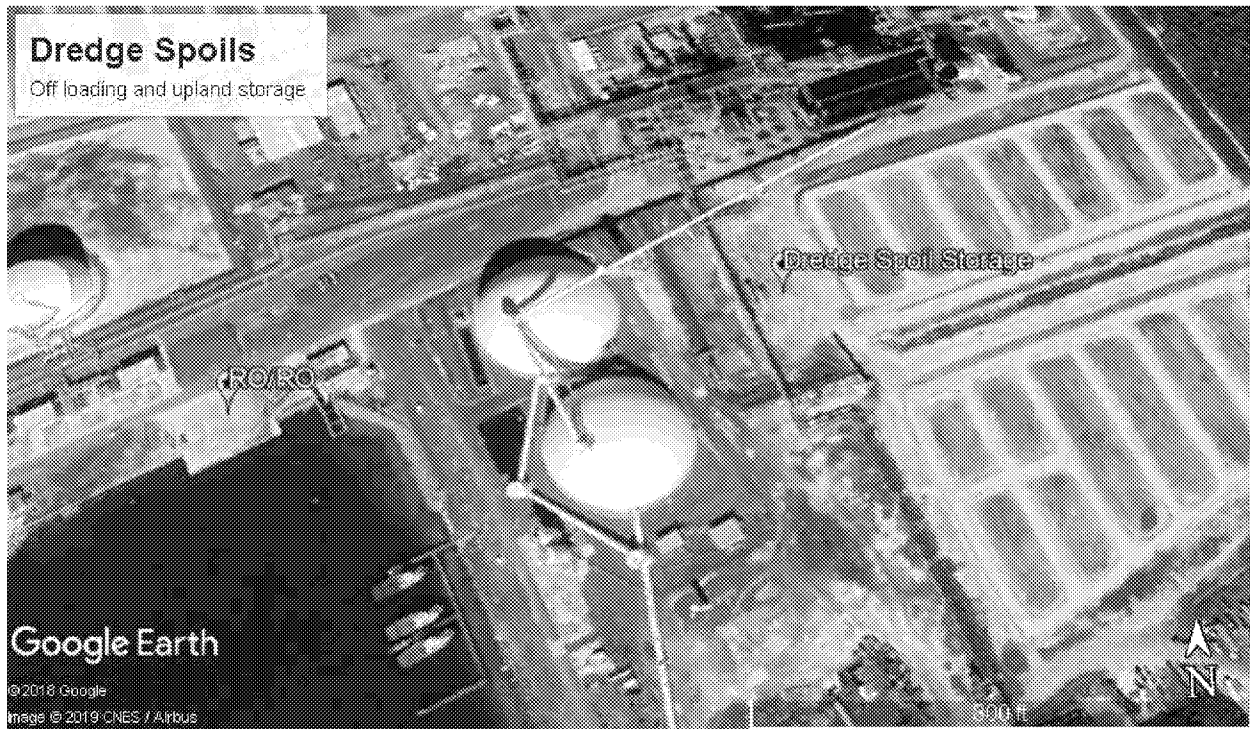
Figure 1 Location of Roll-on/Roll-off Ramp (RO/RO) and upland dredge spoil storage.

The material from the in-channel dredging will be side cast to limit the turbidity of the material being brought to the surface and dewatered.

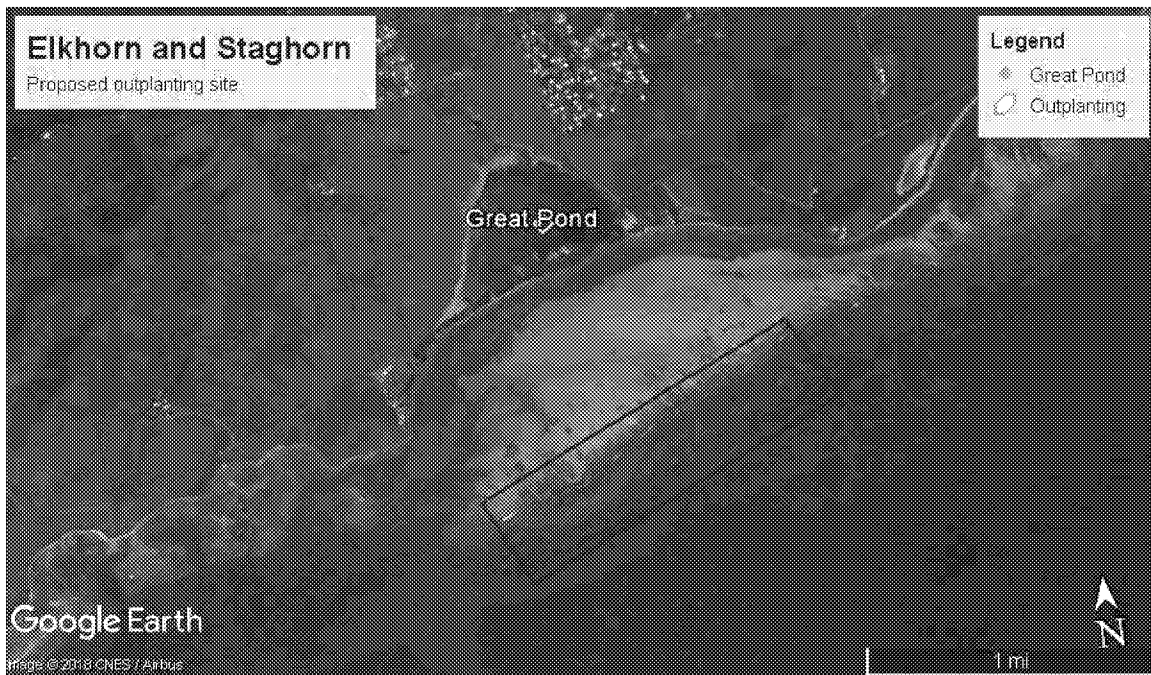
Figure 3. Proposed out planting area. Approximate boundaries: 17°43.071'N 64° 38.620'W, 17°42.610'N 64°39.662'W, 17°42.357'N 64° 39.524'W and 17°42.811'N 64° 38.470'W.

As compensatory mitigation Limetree Bay Terminals will be doing an out planting of 1405 *Acropora palmata*, and 1545 *Acropora cervicornis* a portion of this out planting will be done in the St. Croix East End Marine Park (EEMP). The proposed location of the proposed-out planting will be approximately 6.25 miles to the east of the project site off of Great Pond.

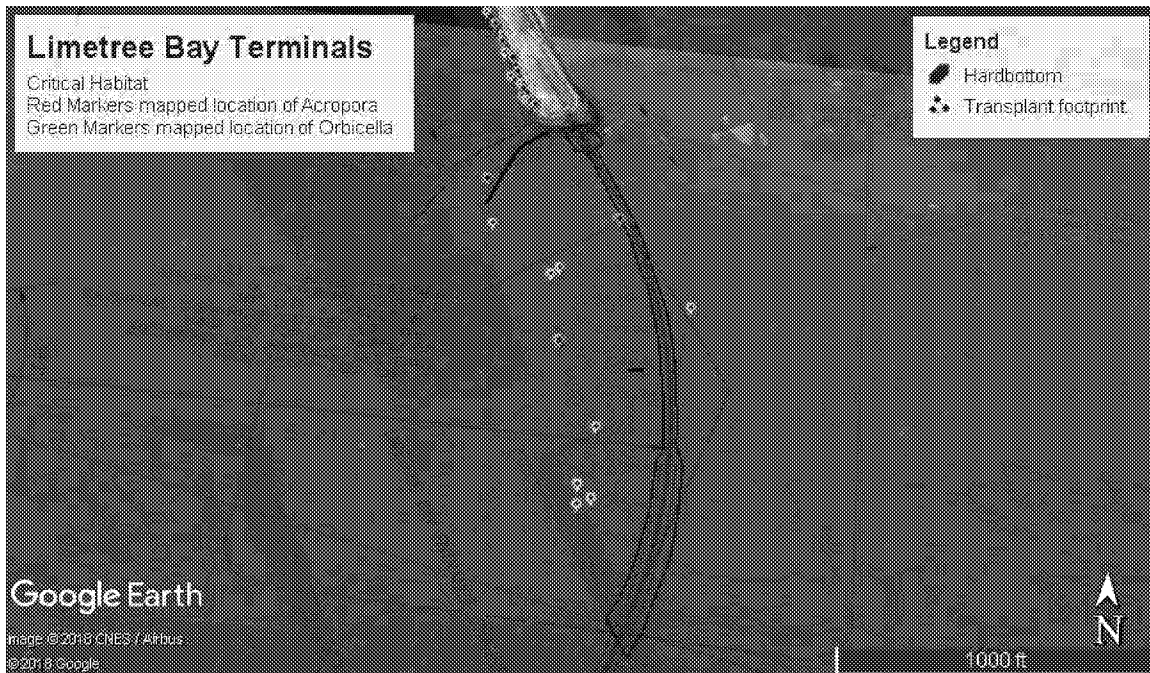
Figure 3. Transplant footprint

Beyond the western channel wall, the seafloor transitions into a pavement with a sand veneer. Like on the eastern side, the channel slope has minimal colonization and approximately 40 corals will be relocated from a swath 35' in length (amount of exposed hardbootm) and 100' wide.

A total of 1760 corals are estimated to be relocated. *Diploria strigosa*, *D. clivosa*, *Porites astreoides* and *Siderastrea siderea* are the most abundant corals in the area. The project footprint avoids all ESA corals; however, it is possible that several *Orbicella faveolata* may occur in the potential impact area. *Orbicella*'s abundance on both the pavement and on the channel, walls was 0.00019/sqft and due the sparseness of these corals on the channel walls it is extremely unlikely that one is within the footprint of impact on the channel walls and was missed during diver survey.

There were no *Orbicella* in the first 300ft off the end of the jetty, however in the area where the pipelines will be trenched down into the channel these *Orbicella* may be present and based on a disturbance footprint of 62' wide (including anchoring/spudding and turbidity impact) and a transplant footprint of 100', 8 *Orbicellas* could occur in this footprint based on their density on the pavement. If an *Orbicella* or any other ESA coral is encountered the applicant will transplant them out of the impact footprint.
